Operating Experience Weekly Summary 97-13

March 21 through March 27, 1997

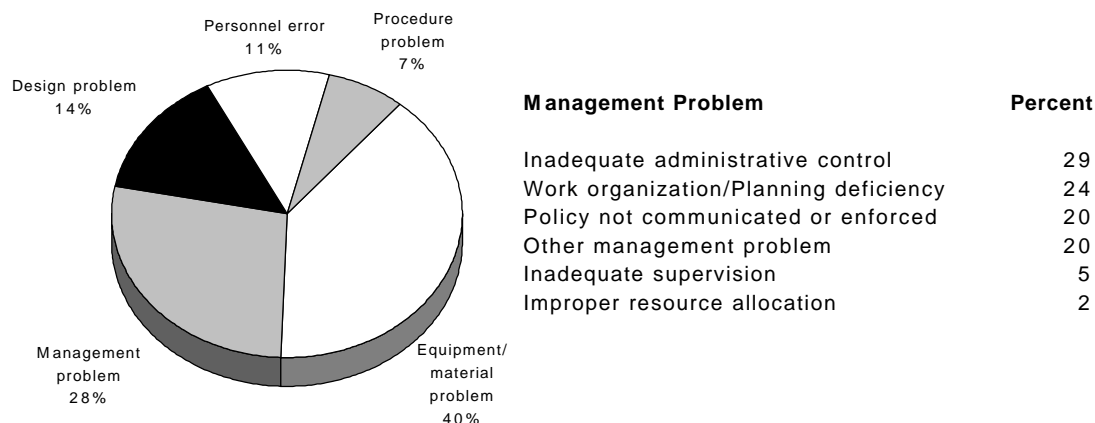
Figure 1-1. Distribution of Root Causes for Fire System Problems¹

OEAF engineers reviewed the Occurrence Reporting and Processing System (ORPS) Graphical User Interface (GUI) for sprinkler head and fire system problems and found 810 occurrences. Figure 1-1 shows that facility managers reported equipment or material problems as the root cause for 40 percent of the occurrences and management problems as the root cause for 28 percent. Further review shows that 81 percent of the reported equipment/material problems were caused by defective or failed parts. Review of the management problems shows that facility managers reported 29 percent as inadequate administrative controls and 24 percent as work organization or planning deficiencies.

These events illustrate the importance of thorough technical reviews and work controls of modifications and a disciplined configuration management program. Work controls and configuration management do not apply to any one discipline, but to all areas of a facility. They encompass any and all changes made or proposed to a facility or change of mission. Proposed modifications to a system need to be thoroughly reviewed, and the impact on the design basis of other systems should be evaluated. Facility managers should ensure all personnel are made aware of the need for stringent work controls and configuration management. Facility managers should also ensure that work controls and configuration management programs, verification, and approval are conducted by personnel qualified for the specific discipline involved. They should also ensure that verifications include the current codes for that particular discipline.

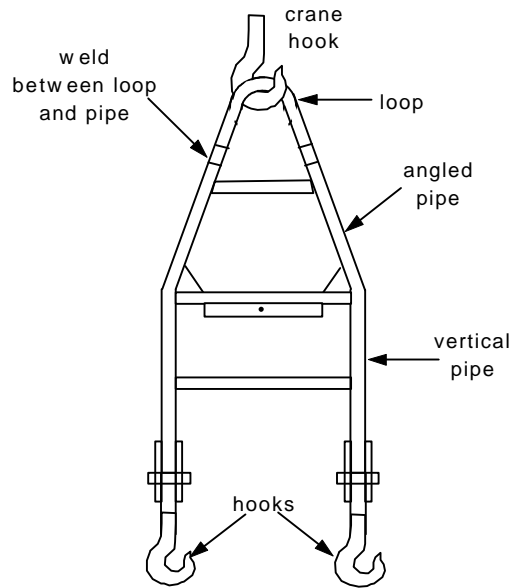
Figure 3-1. Lifting Device Assembly

On March 13, 1997, at the Idaho Chemical Processing Plant, engineering personnel discovered discrepancies between an equipment drawing for a fuel handling cask lifting device and the nameplate capacity. The drawing indicated a lifting device design capacity of 15 tons and the nameplate showed a capacity of 20 tons. Investigators reviewed the load-testing records for the lifting device and discovered it was last tested in 1993. Since 1985, it has been tested to 150 percent of the nameplate capacity eight times. However, testing was actually to 200 percent of the 15-ton design capacity. The facility manager removed the cask lifting device from service. Improper labeling of equipment and failure to verify the labeling as correct created the potential for injury or equipment damage. (ORPS Report ID--LITC-FUELCSTR-1997-0004)

Investigators determined the lifting device has been used since 1977, and they believe it was site-fabricated. Investigators believe the in-field lifting capacity was changed in 1985. They also believe engineers tested the lifting device to 150 percent of its rated capacity, or 22.5 tons, and backed the "proposed rated capacity" down from 22.5 tons to 20 tons. Engineers then mistakenly marked the lifting device at 20 tons. Investigators determined that hand calculations made in 1985 showed the lifting device met the 5 to 1 ultimate load criteria; however, the lifting loop was not considered in these calculations.

Engineers determined that, because the lifting device was inadvertently tagged at 20 tons, it was routinely tested with a load of 31 tons. They performed a stress analysis using hand calculations and IDEAS™-based finite element analysis on the lifting device. The analysis indicated that routine load testing stressed the lifting device past the material yield point (stress) in the lifting loop and hook areas. Engineers estimated the lifting device has been over-stressed eight times since 1985. They found no material yielding or external visible adverse effects on the lifting device during their inspection. Further analysis of the lifting device indicates that several areas do not meet the safety factors stated in the plant safety documents. The plant safety documents for engineered safety features require lifting devices to be designed with a safety factor of five times the load rating. ASME B30.20-1993, *Below-The-Hook Lifting Device*, requires lifting devices to be designed with a safety factor of at least 3, based on the material yield strength. The five lifting device sections identified in Figure 3-1 do not meet the required yield strength safety factor of 3. Additionally, the loop and the hooks do not meet the material ultimate strength safety factor of 5.

The facility manager directed engineering personnel to check other lifting devices fabricated during the 1977 era to ensure engineering stress requirements are being met. Engineers are continuing to investigate to determine why the lifting device was upgraded from 15-ton to 20-ton capacity.
